# Unexpected Inhibition of Pacing in a Patient with Complete AV Block after Upgrade of a Pacemaker to a Defibrillator: What is the Mechanism?

April 28, 2020

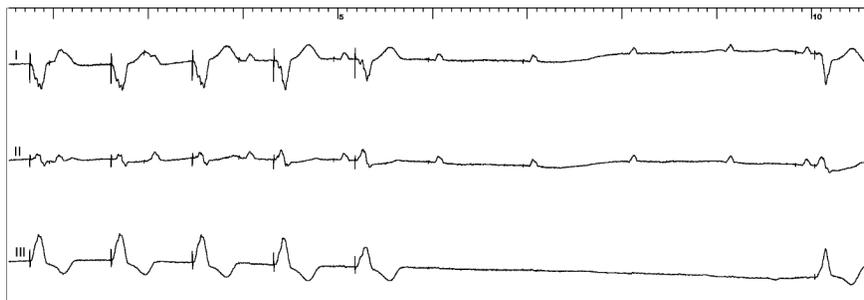
Shortly after explantation of the old pacemaker generator, complete heart block occurred. The old pacemaker battery was quickly reconnected to reestablish pacing and to assess the situation. What is the mechanism of ventricular pacing inhibition, and what is the best solution? [Fig. 1, Fig. 2]

Figure 1: Electrocardiogram during intermittent AV-Block (paper speed 25 mm/sec)

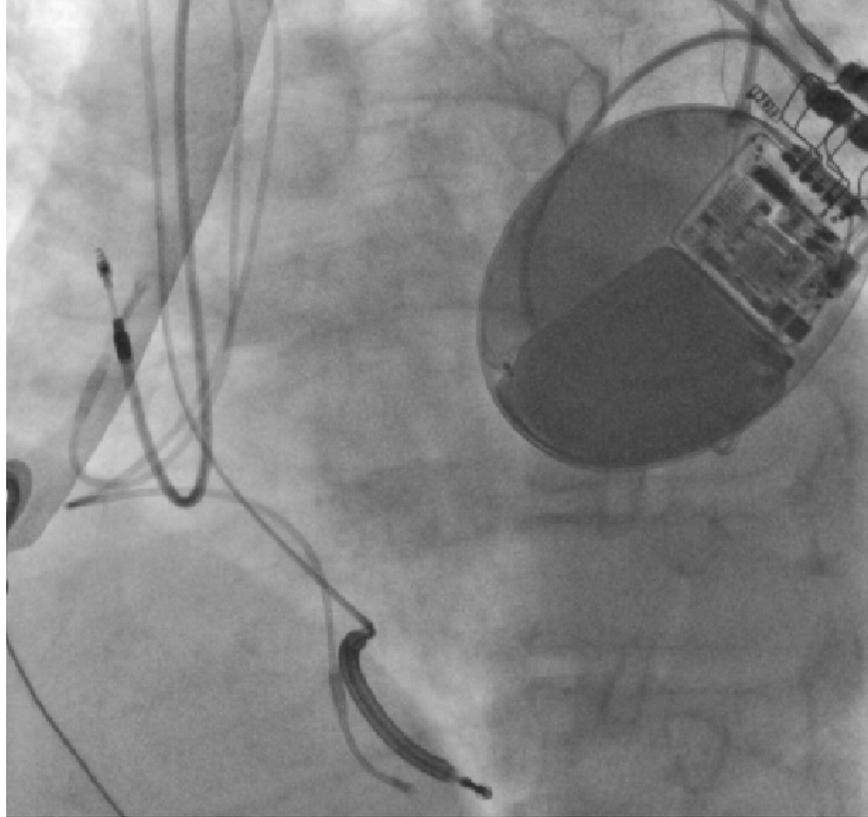
We observed that mechanical contact between the old pacemaker and the new integrated bipolar defibrillator lead caused oversensing (“lead chattering”) resulting in inhibition of ventricular stimulation.

In integrated bipolar leads the distal shock coil serves as the sensing anode. Their architecture is less complex than those of dedicated bipolar leads and they are less prone to T-wave oversensing and anodal stimulation [1, 2]. On the other hand, the large surface area of the sensing anode (which consists of the entire distal shock coil) renders these leads more prone to sensing of short VV intervals [3], P-wave oversensing, P-wave double-counting [2,4], diaphragmatic oversensing [5], or oversensing due to non-physiological electrical signals that are generated during interactions with other intracardiac leads. The large surface area of the high-voltage coil is more likely to touch an abandoned lead than the ring electrode of a true bipolar ICD lead. This mechanical interaction, or lead-chatter, can cause oversensing and inappropriate shocks [6] or, as in this case, inhibition of pacing due to oversensing. A true bipolar ICD lead should therefore be preferred in patients with abandoned ventricular leads.

Figure 2: Fluoroscopy (45°left anterior oblique view) of the lead configuration during AV-Block. Note the proximity of the old ventricular pacing lead to the distal shock coil, which serves as the anode of the integrated bipolar defibrillator lead.

1. Implantation of an additional septal pace/sense lead in appropriate distance to the integrated bipolar lead.
2. Explantation of the new integrated bipolar defibrillator lead and exchange against a true bipolar ICD lead.
3. Extraction of the 21 year old ventricular pacemaker lead.

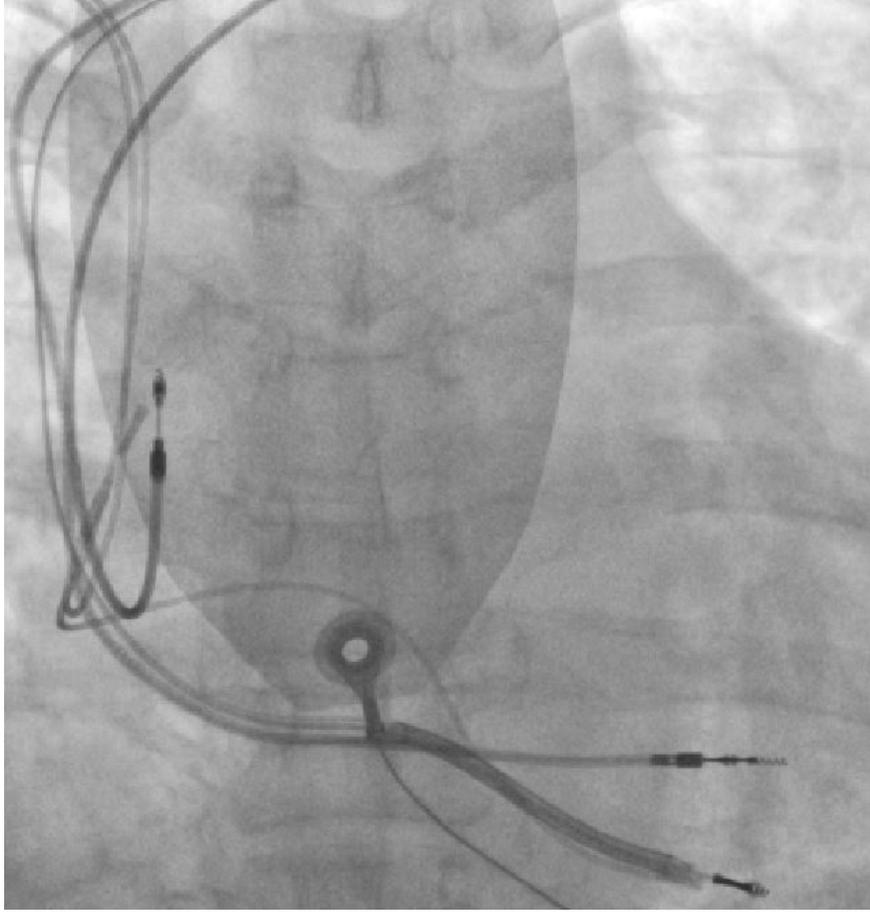
Figure 3: Fluoroscopy (PA view) of the lead configuration after addition of a pace/sense lead in the inter-ventricular septum.

Since we had utilized a DF-1 system, we decided to add a pace/sense lead and use the single-coil DF-1 part of the defibrillator lead which was placed in a good right ventricular apical position. [Fig 3.]
