Retrieval of the retained intervention guide wire from deltoid muscle- A rare and delayed presentation post cardiac resynchronization therapy (CRT-D) lead replacement.

Vimal Yadav¹, Shailesh Jhanwar¹, Brij Goyal¹, and Surendra Patel²

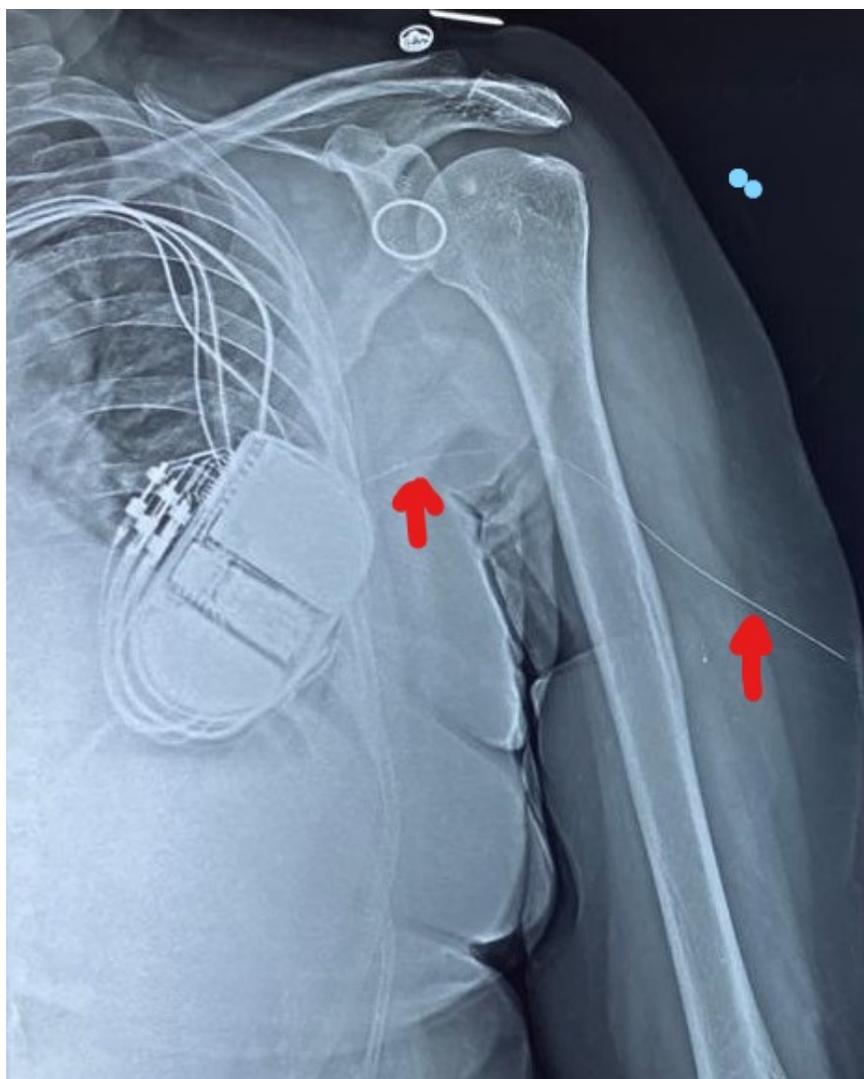
Figure 1: X-ray chest showing wire-like opacity extending from the pocket of the CRT-D device to left upper arm (red arrow)

On examination, a wire tip like foreign material was palpable in the left upper arm which became more prominent on elevation and abduction of the arm. Therefore, she was subjected to undergo a chest x-ray which showed wire-like opacity extending from the pocket of the CRT-D device to left upper arm [Fig.1]. Computed tomography (CT) of thorax with contrast was done which confirmed the presence of the foreign body in the left upper arm [Fig.2], and upper limb vessels showed normal contrast opacification. Fluoroscopy showed the wire-like foreign body extending from the pocket of CRT-D to left-arm [Fig.3]. Surgical exploration was planned with an intent to remove this wire. A longitudinal incision was applied over the left upper arm over the palpable foreign body. The wire was impacted in the deltoid muscle and reached up to subcutaneous tissue, which was dissected and retrieved completely. There was no neurovascular injury noted. The retrieved wire resembled a coronary guidewire with coating and radiopacity at the distal tip which must have been used to deploy the pacemaker lead during the last procedure. The CRT-D device was programmed and checked for all parameters and was found to be properly functional. Postoperative recovery was uneventful and the patient was discharged on the second postoperative day. After 2 weeks of follow up, the patient was asymptomatic and had full recovery of the surgical wound.

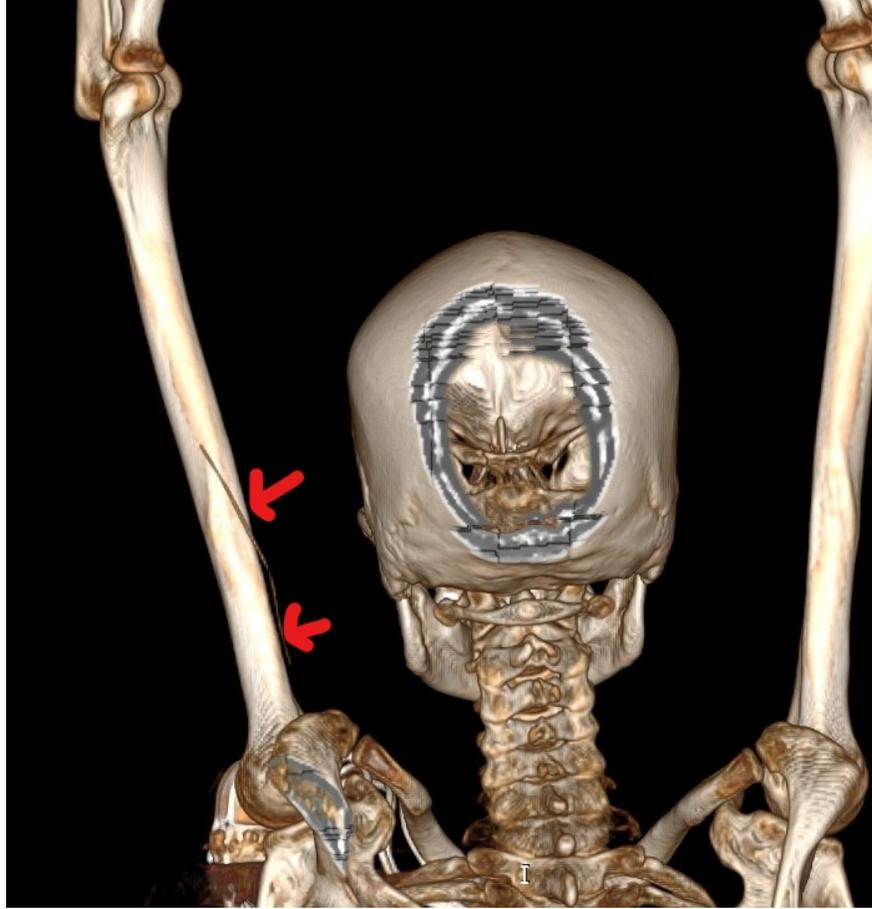
Figure 2: Volume rendered (VR) 3D images of the chest computed tomography showing the presence of wire in the left arm (red arrow)

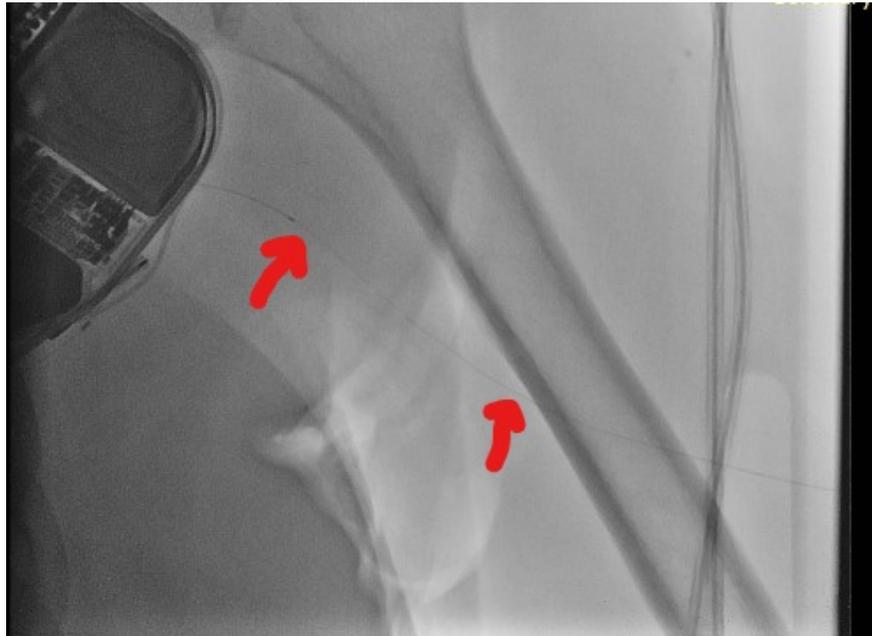
Figure 3: Fluoroscopic image showing the wire-like foreign body extending from the pocket of the CRT-D device to left arm (red arrow)
