# Monitoring multiple damage mechanisms in crack-patched structures using optical infrared thermography

Ulrike Martens<sup>1</sup> and Kai-Uwe Schröder<sup>1</sup>

<sup>1</sup>RWTH Aachen University

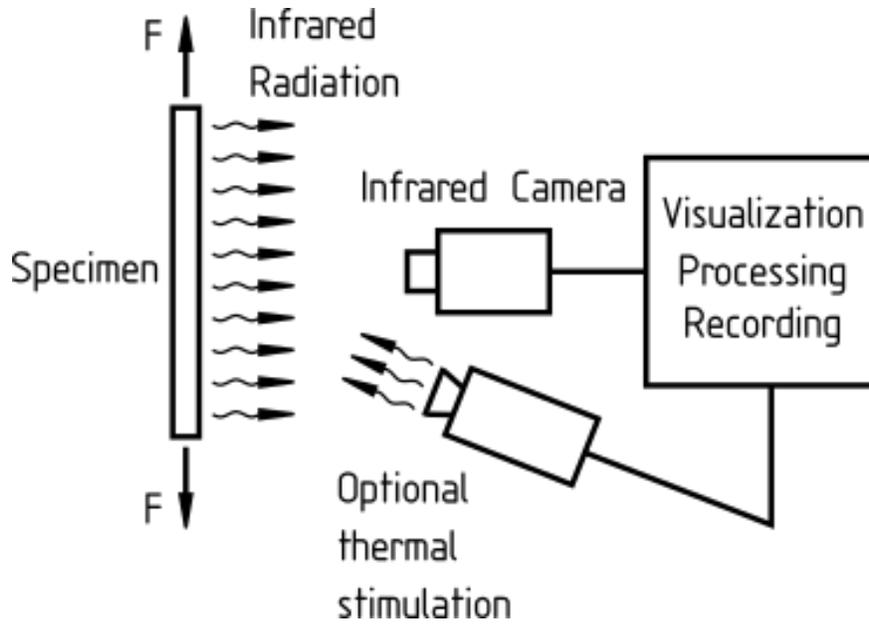
In the present examination, passive IrT and supplementarily also optical LT are applied to monitor the damage behaviour of mechanically loaded crack patched specimens. A sketch of the test setup of IrT can be found in Fig. 1. On the right hand side the loaded specimen is depicted which sends varying infrared radiation due to varying loading.

Fig. 1: IrT setup according to [6]

This infrared radiation is detected by the camera, which is connected to a processing unit that converts the radiation data into thermal images. An optional thermal stimulation unit is needed for active IrT methods. The method of passive IrT measures the temperature variations on the object's surface. Internal conversion processes for instance, that go along with (local) temperature changes can be detected measuring the attending changes in infrared radiation. Thereby, temperature hot spots resulting from crack formation and crack growth processes for instance can be detected. For more detailed information on IrT see [6].

Active IrT methods on the other hand use external excitation units for the thermal stimulation of the specimen. Optical LT for instance uses an external heat source, denoted as optional thermal stimulation in Fig. 1, introduces a heat flow into the specimen. The energy flow moves through the specimen and is partly reversed at material boundaries, such as voids or similar. The reversed energy flow is detected by the IrT camera system. Local differences in infrared radiation can thereby be visualized. This way, thermal images can be used to find subsurface irregularities.

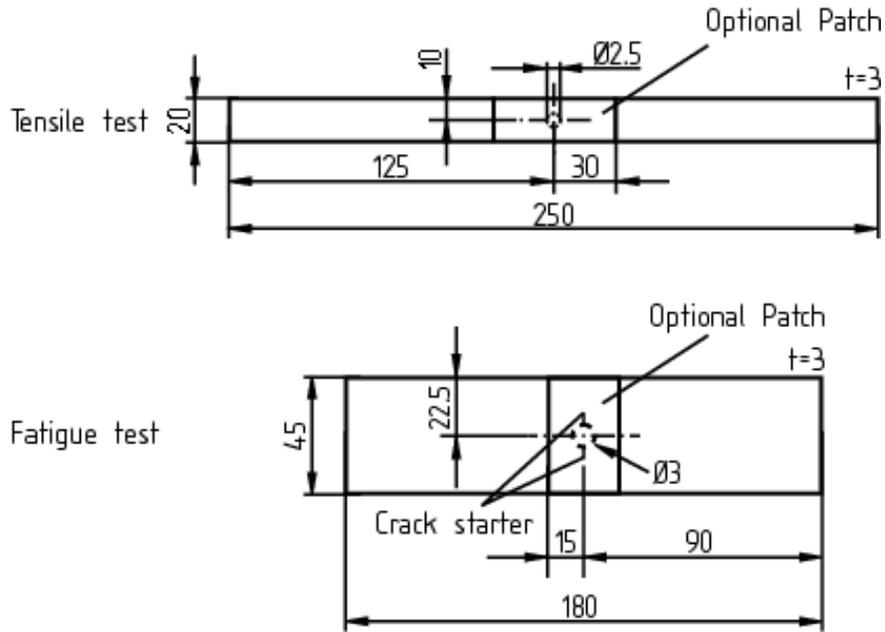
All specimens are made of aluminium 5083 with a thickness of  $h = 3$  mm. The patch material used is a 0/90 epoxy-based carbon fibre reinforced plastic prepreg (SGL Technologies GmbH of type C W410-TW2/2-E323/42%/6k and a ply thickness of  $h = 0.6$  mm). Specimen geometries and dimensions are given in Fig. 2.

Fig. 2: Specimen geometries

For the fatigue specimens hand sawn cuts of 2 mm length each and placed perpendicular to the load direction act as a crack starter. Specimen preparation is kept simple since the focus lies on the monitoring methods and not on the patch performance. After cleaning the metal sheets with acetone, patches are directly bonded without using an extra adhesive layer. Specimens are heated in a temperature chamber ( $T = 100^{\circ}\text{C}$ ,  $t = 2 \text{ h}$ ) placed on a metallic sheet and covered by a plastic foil. A vacuum pump is applied throughout the heating process in order to create a proper bonding.

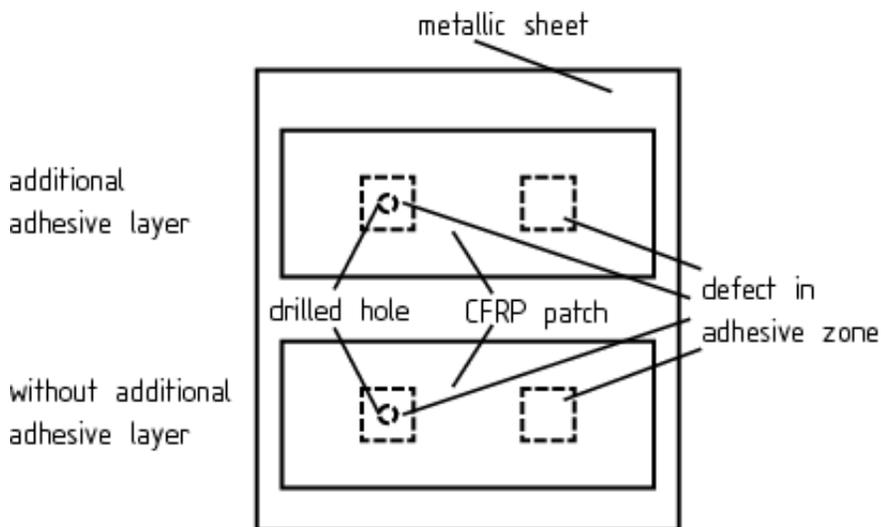
At first, a metallic plate without mechanical loading is examined using optical LT. The aim of this preliminary test is to qualitatively find out whether or not it is possible to detect a crack in the metallic plate lying underneath a local defect in the adhesive layer. The specimen design can be seen in Fig. 3.

Fig. 3: Geometry preliminary test

One layer of a biaxial CFRP prepreg material is mounted on the metallic substrate to simulate the repair patch. The defect in the metallic plate is simulated by a drilled hole of 6 mm in diameter. Two different patch configurations are tested, one with an extra adhesive layer (DuploTEC 10400, Lohmann) and the other using the epoxy itself joining the components. A small square of newsprint is intentionally worked in the specimen between the patch and the metal to simulate local patch delamination.

For LT, the measurement depth is dependent on the lock-in frequency as well as the number of lock-in periods. The pure delamination defect on the right-hand side of the specimen is used to calibrate the camera for the defect depth. The second defect is a combination of local patch detachment and a defect in the metallic part simulated by a drilled hole underneath.

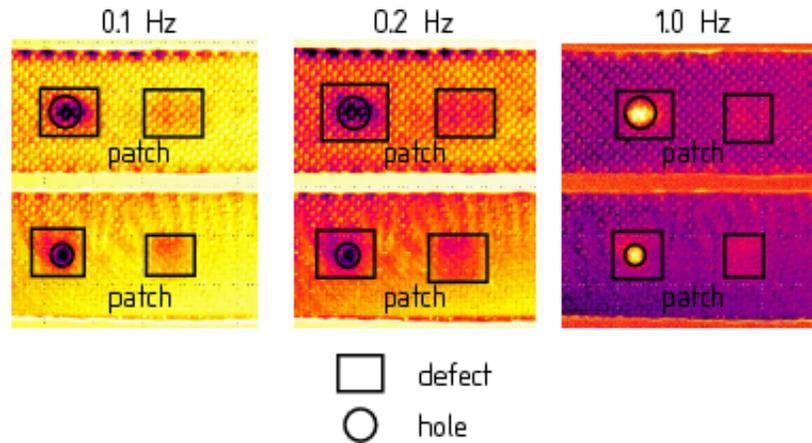
Fig. 4 shows the thermal images for the lock-in frequencies of  $f = 0.1$  Hz,  $f = 0.2$  Hz and  $f = 1$  Hz.

Fig. 4: Results preliminary test

For all frequencies tested, the square defect on the right-hand side of each picture can clearly be seen. On the left-hand sides, the square damage as well as the hole in the metal can be detected. This means, that the detection of both defect types is possible within a certain range of lock-in frequencies. It can further be seen that the outlines of the defects are more clearly visible for the lower configuration without an additional adhesive layer than for the upper one with an adhesive layer.

Nevertheless, for both configurations the defects are visible. As a conclusion one can say, that LT is generally capable to detect a damage in the metallic part of a patch repair that is lying underneath a local defect in the adhesive layer. Since a hole of 0.6 mm is not representable in dimension for a fatigue crack, the applicability of this method to detect small cracks thus needs to be further analysed. Statements concerning the influence of patch thickness cannot be made either so far.

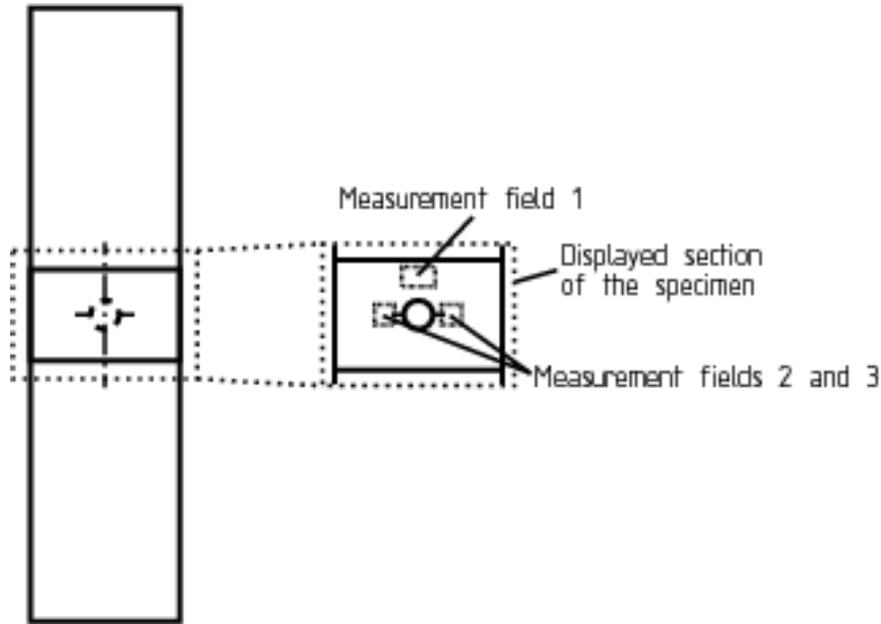
surface. The first above the hole for the minimum temperature and the second and third at the crack tips for the maximum temperature, see Figure 5.

Figure 5: Displayed section of the specimen and measurement fields used to read out temperature values. Fields 2 and 3 move with the crack tips towards the specimen edges with increasing crack length. Maximum and minimum temperature values are read out by the software.

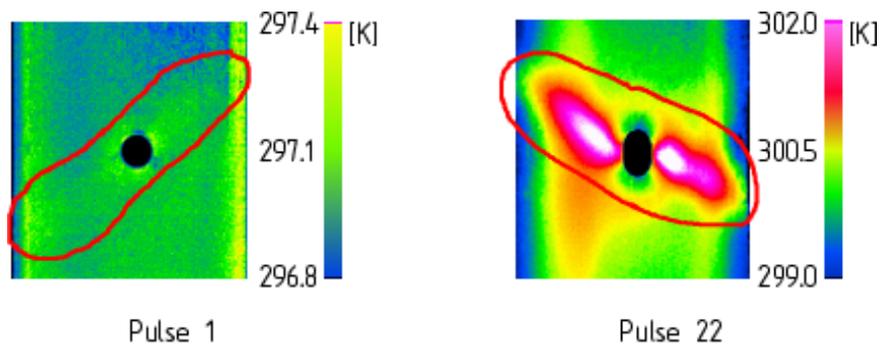
To get a first idea about the thermal behaviour of the metallic specimens under loading, quasi-static tests with metallic specimens are performed. Test evaluation shows that during the entire test, changes in the local temperature can be seen. After exceeding the linear-elastic region of the material, heat “flashes” can be seen on the thermal images as 45-lines to the loading direction, see Fig. 6.

Fig. 6: First and one of the last detectable slip bands

The picture on the left-hand side shows the first detected pulse and the picture on the right-hand side one of the last ones. The load/displacement curve shown Fig. 7 helps to arrange the pulses within the test course.

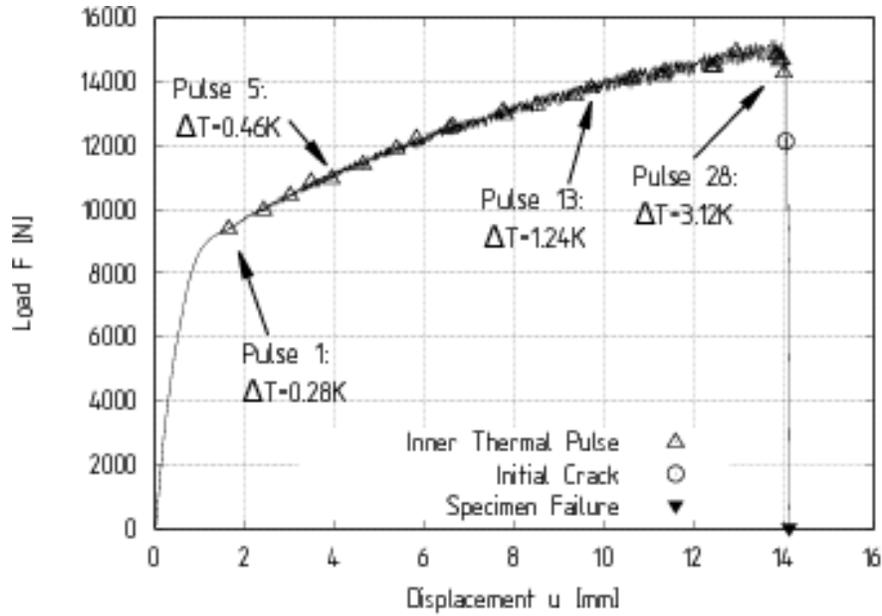
Fig. 7: Load/displacement curve for a specimen without patch

The course of the load/displacement curve is described by drops in the force signal that increase over time. The non-smooth load/displacement behaviour in the plastic region leads to the conclusion that this phenomenon can be related to the so-called “Portevin-Le Chatelier” (PLC) effect. The temperature “flashes” are slip bands running through the material. For more information on the PLC effect see for instance [16]. Number and size of the drops in the force signal correspond to the frequency and intensity of the detected slip bands running through the specimen. Monitoring the region around the hole, where crack onset is expected, the increase in number and intensity can be seen. Slip bands running through the hole pile up and local temperature differences increase over testing time, as shown in Fig. 8.

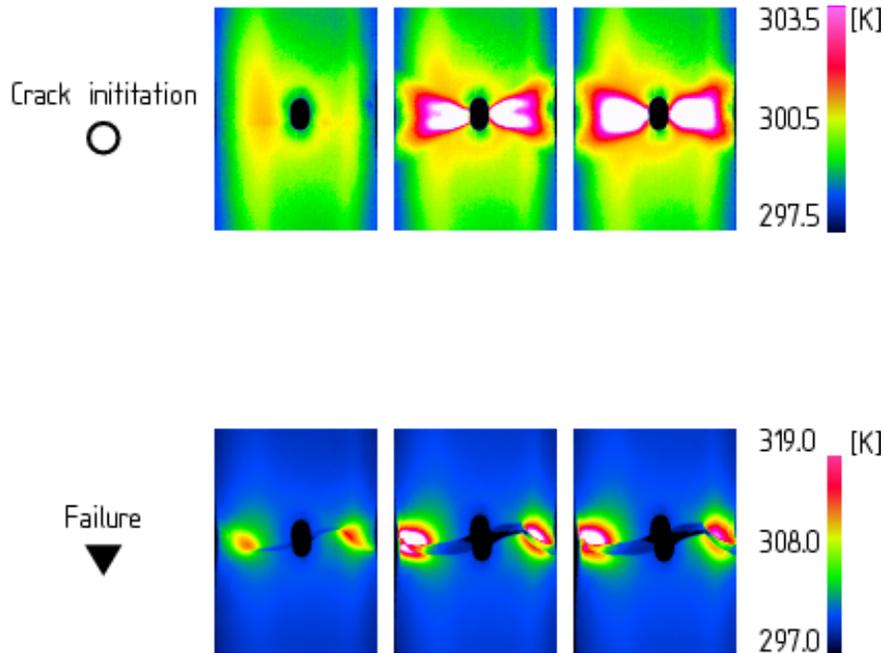
Fig. 9: Crack initiation and final failure

Right before crack initiation, marked with a  $\circ$ , a last high-intensity pulse runs through the hole (here, pulse 28). Final break is marked with the symbol  $\blacktriangledown$  in the load/displacement curve. At crack onset the heat increase at both sides of the hole is clearly detectable with a maximum temperature difference of  $T = 17.1$ K. Also, for final break, the crack tip running through the specimen is well-defined as a local temperature increase. The maximum temperature difference can be measured to be  $T = 36.47$ K.

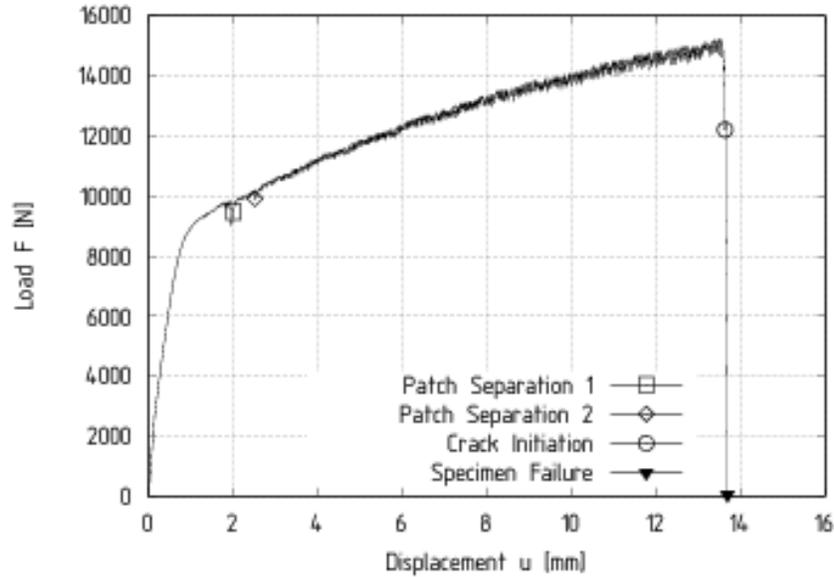
additional information compared to the specimens without patch. A comparison of the load/displacement curves and the thermal images shows that the damage behaviour including the characteristic events of specimen failure are comparable. The patch detaches in a one- or two-stage process resulting in one or two additional characteristic event(s) in the load/displacement curve, as shown in Fig. 10, denoted with the symbols  $\square$  and  $\diamond$ .

Fig. 10: Load/displacement curve for a specimen with patch

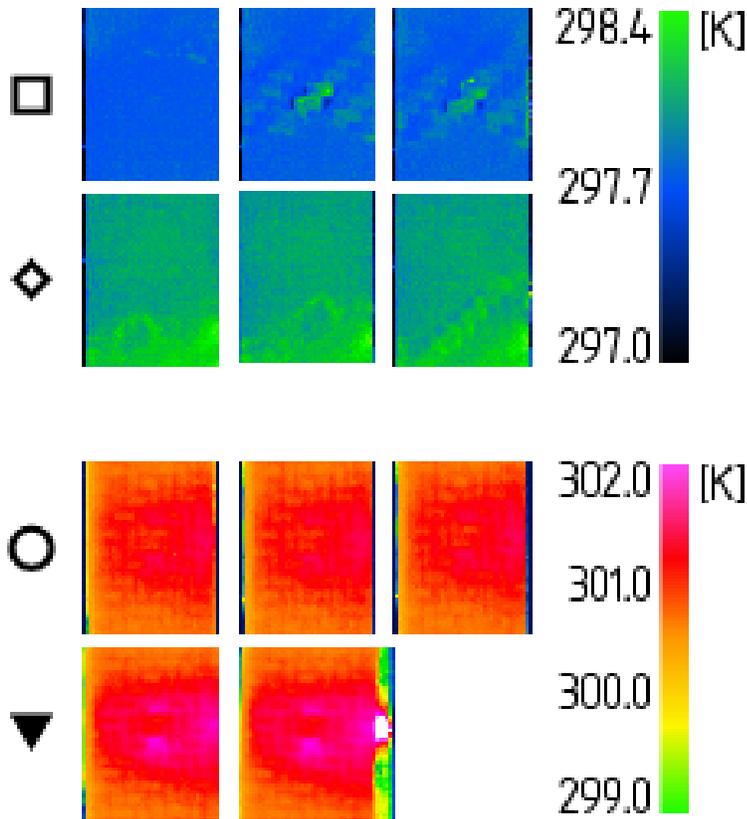
Fig. 11: Patch detachment 1 and 2 , crack initiation and final failure

Again, the images show the region around the hole which is covered by the CFRP patch and whose woven structure can be identified. For each event three consecutive images are shown that are found to be taken close to the characteristic events.

The two points of patch detachment (  $\square$  and  $\diamond$  ) show a slight diagonal increase in temperature around the central hole. In the first row two diagonal lines can be seen and in the second one only one line. It seems that these temperature increase can be related to metallic slip bands. But it actually cannot clearly be said whether these lines of increased temperature result from diagonal slip bands or from the diagonal structure of the patch.

Considering crack initiation (  $\circ$  ) and final failure (  $\blacktriangledown$  ), an increase in temperature can be seen through the patch in the specimen centre. As the patch is already detached around the hole, outlines are blurred and only a non-specific field of increased temperature can be made out. The temperature difference here lies at around  $T = 45$  at the patch surface, compared to a  $T = 7.1\text{K}$  for the temperature increase measured at the metallic surface. The very last picture covers the moment of patch detachment. The actual temperature increase around the hole can be seen at the right-hand side where the metal sheet is not covered by the patch. While the temperature difference is more than  $T = 8\text{K}$  at the edge of the metallic part, on the patch surface only difference of around  $T = 2.59\text{K}$  is detectable.

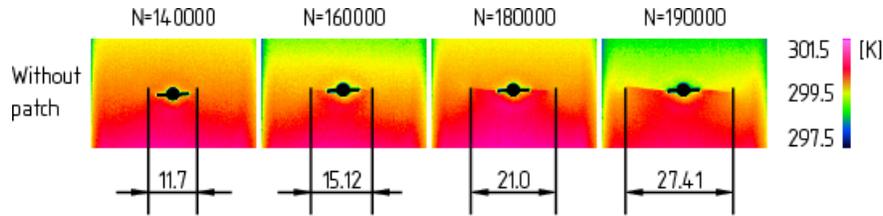
Thermal images of one exemplarily chosen unpatched specimen, shown in Fig. 12, depict the temperature development during crack propagation for four exemplarily chosen numbers of load cycles  $N$ .

Fig. 12: Crack propagation process for an unpatched under fatigue loading

Monitoring the metallic crack growth with passive IrT shows that the longer the crack grows, the better it can be made out on the thermal image. For small crack lengths on the other hand, crack tip detection can be difficult. One reason might be, that the movement of the lower piston heats up the specimen during testing. Temperature thus increases from the bottom to the top and the crack acts as a heat barrier. The bigger the temperature differences become over time, the easier cracks can be made out. Moreover, a circular area around the crack tip can be identified which builds up during loading and vanishes while unloading the specimen. This area helps to identify the crack tip and thereby to measure the crack length.

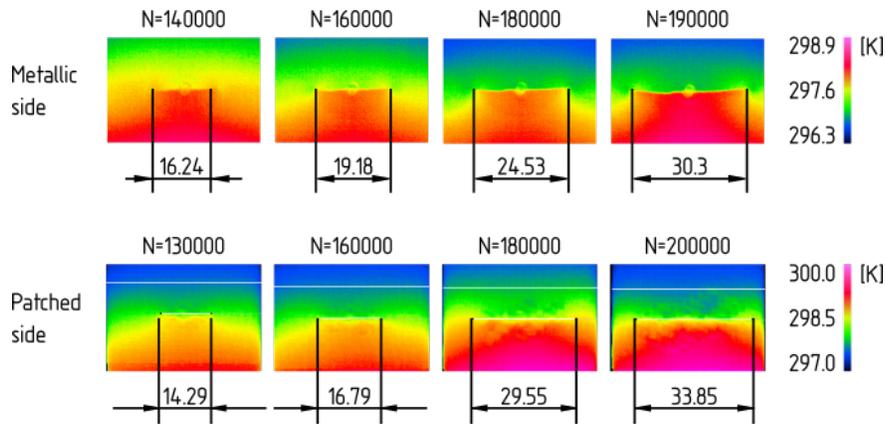
As for the quasi-static test, differences between the images from the unpatched specimen and the ones with patch monitored from the metallic side are neglectable. Fig. 13 shows the temperature evaluation for two patched specimens, one monitored from the metallic side and the other from the patched one.

Fig. 13: Comparison crack propagation process for two patched specimens under fatigue loading monitored from the metallic and the patched side

resulting in decreasing visibility of the crack. Local patch delamination can be identified on the thermal image as areas where the woven structure of the patch is noticeable. But still, crack propagation process can be monitored. Comparing crack length and detachment dimensions it seems that right in front of the crack the patch has already delaminated from the metal. Meaning that for the given specimen configuration and the given conditions presumably delamination around the crack tip appears before the crack grows. To further corroborate this hypothesis additional tests using complementary monitoring techniques have to be made.

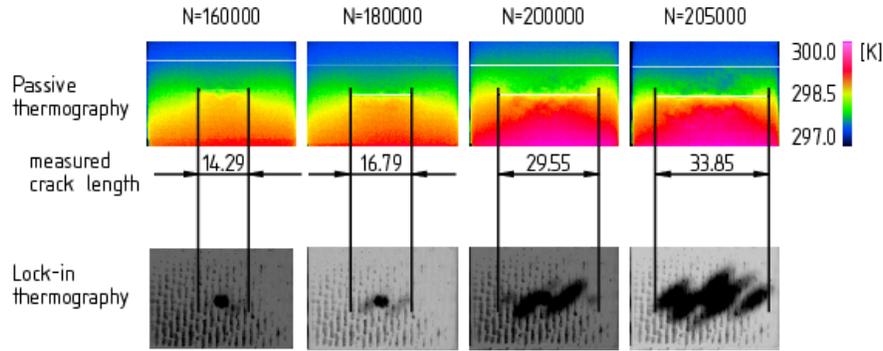
that is monitored from the patched side. A comparison of the thermal images gained from passive IrT and phase images resulting from LT measurements are displayed in Fig. 14.

Fig. 14: Comparison crack propagation process using passive IrT and LT

Local patch detachment can be made out as dark spots on the phase images, comparable in size and contour lines with the results gained from passive IrT. The crack on the other hand cannot be identified on the phase images.
